EXHIBIT 1

Storage Tank Integrity Report

200KG Reservoir

City of Paisley

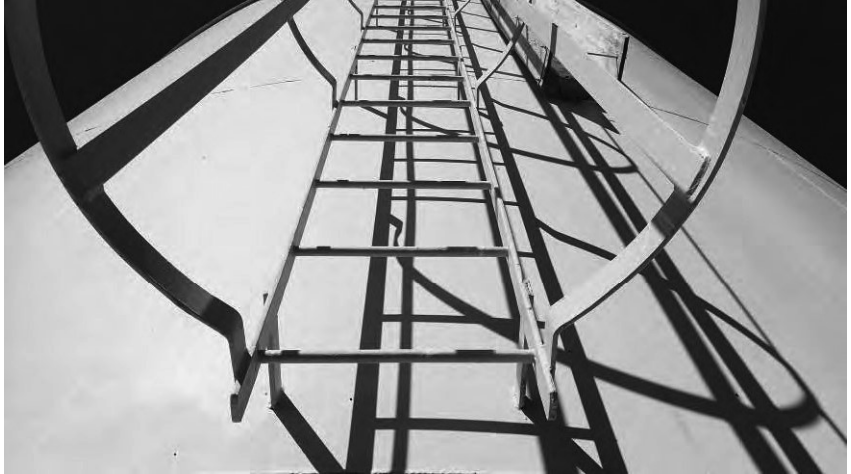
Condition:
Rust Grade¹ 3.

Description:
Exterior Ladder appeared to be in good condition with a minor amount of corrosion.

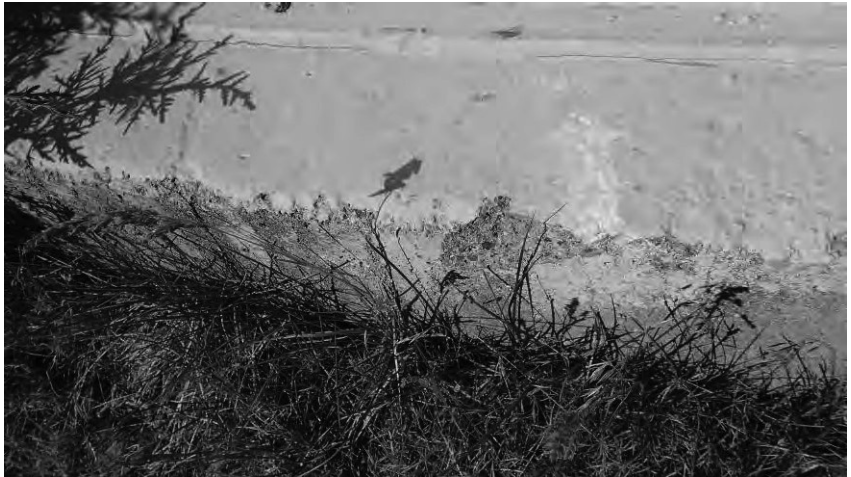
Image #2

Exterior Base 1:00

Condition:
Concrete Deform³ DL.

Description:
Exterior Base appeared to be in fair condition with a moderate amount of delamination.

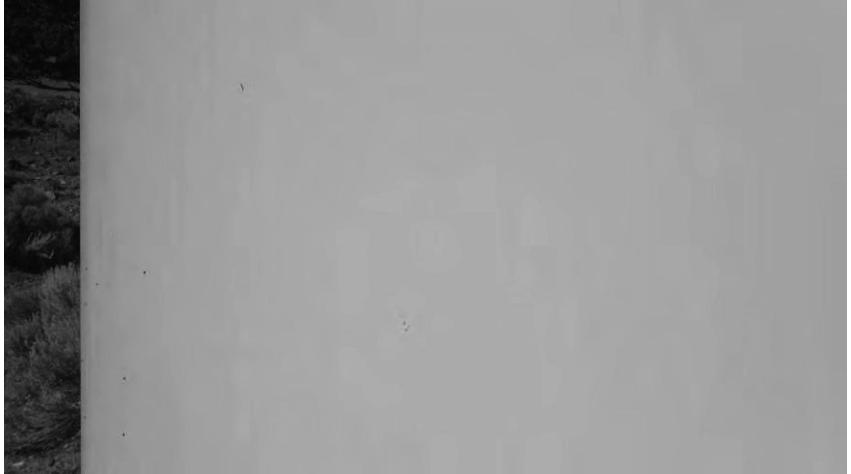
Image #3

Condition:
Rust Grade¹ 8.

Description:
Exterior Wall appeared to be in good condition with a minor amount of corrosion.

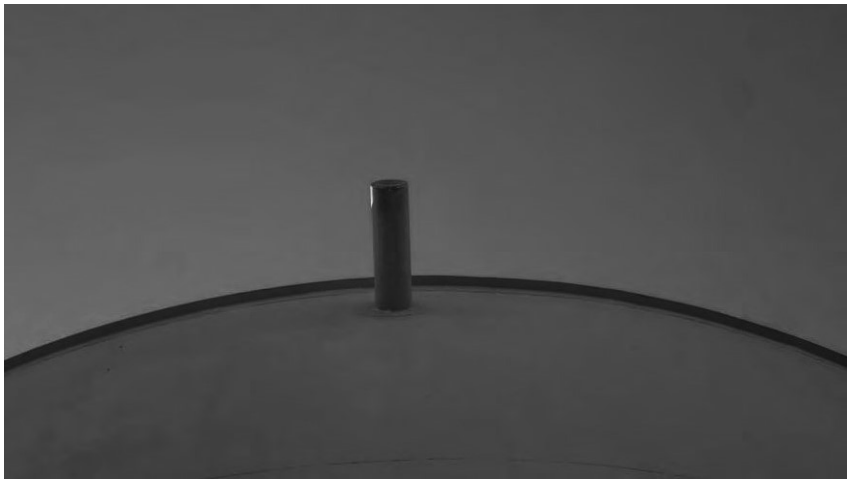
Image #4

Overflow 9:00

Condition:
Rust Grade¹ 7.

Description:
4" Overflow appeared to be in fair condition with a minor amount of corrosion.

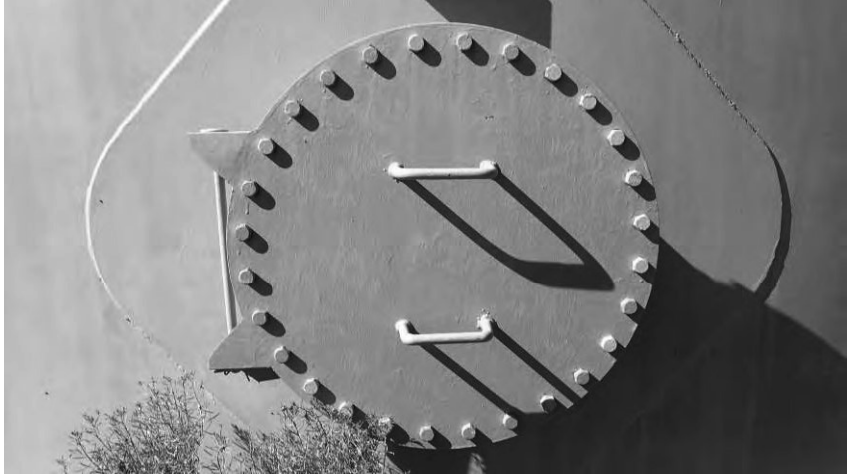
Image #5

Condition:
Rust Grade¹ 8.

Description:
36" Man Way appeared to be in good condition with a minor amount of corrosion.

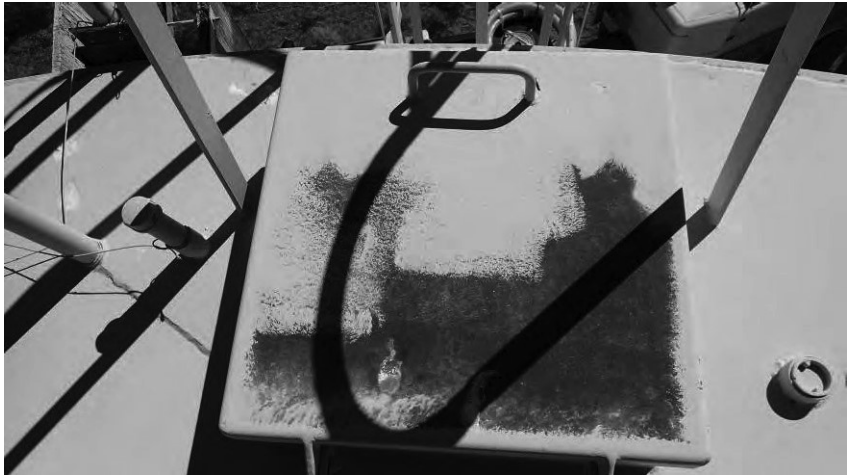
Image #6

Entry Hatch 12:00

Condition:
Rust Grade¹ 8.

Description:
24" X 24" Entry Hatch appeared to be in good condition with a minor amount of corrosion. Entry hatch does not have weather stripping.

Recommendation	Estimated Time - Hrs.
Install weather stripping on entry hatch to limit the risk of bugs and other matter from entering the reservoir.	1 HR
Perform a regular cleaning, inspection and repair cycle every 2-3 years in order to ensure superior water quality and proper maintenance of coating condition and appurtenances is performed.	Please contact our sales office for an estimate.

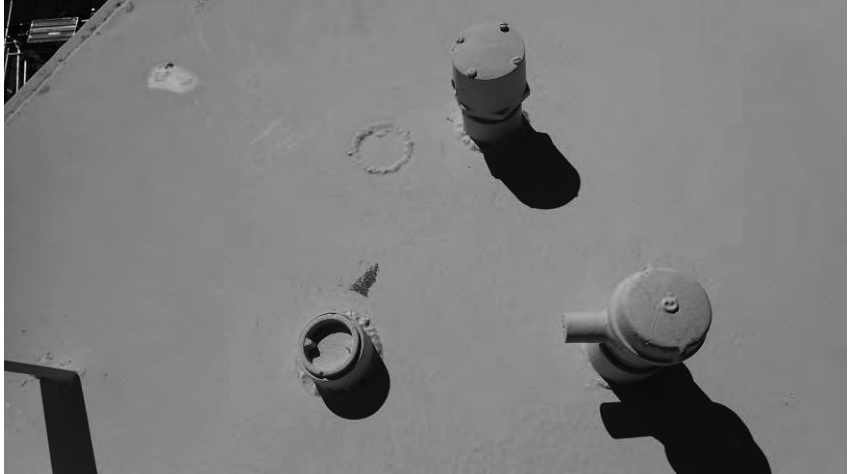
Image #7

Condition:
Rust Grade¹ 8.

Description:
1 1/2" Capped Off Penetration appeared to be in good condition with a minor amount of corrosion.

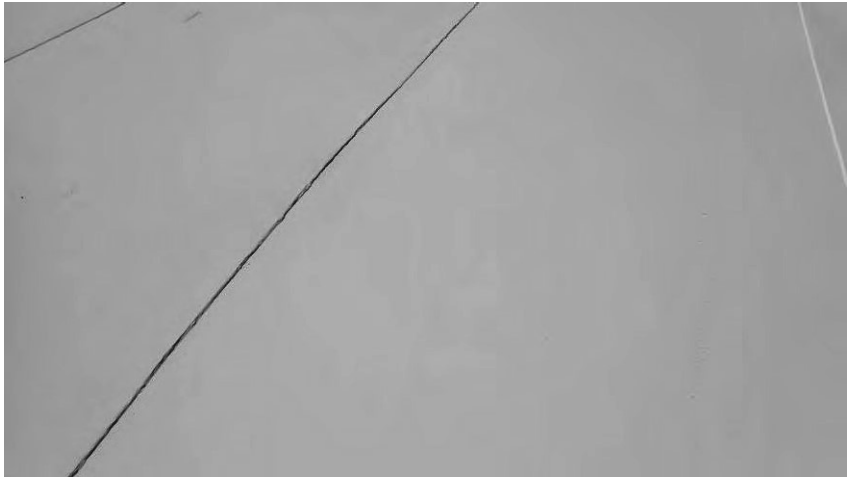
Image #8

Roof 3:00

Condition:
Rust Grade¹ 9.

Description:
Roof appeared to be in good condition with a minor amount of corrosion.

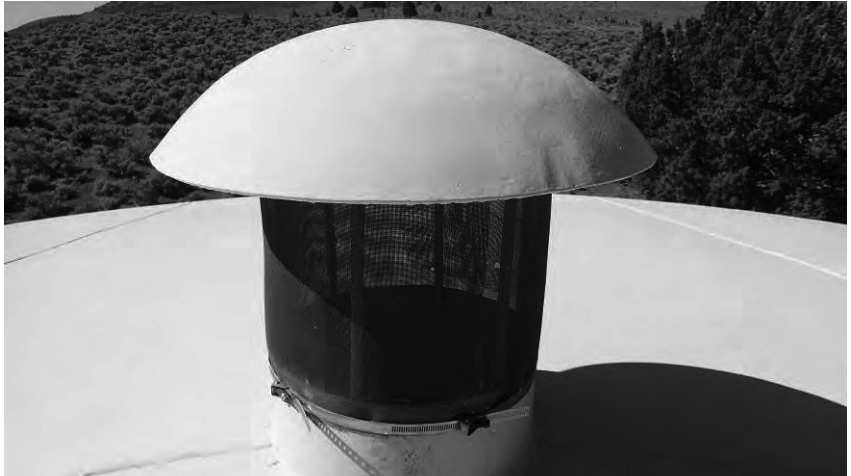
Image #9

Condition:
Rust Grade¹ 8.

Description:
12" Vent appeared to be in good condition with a minor amount of corrosion. Vent has fine mesh.

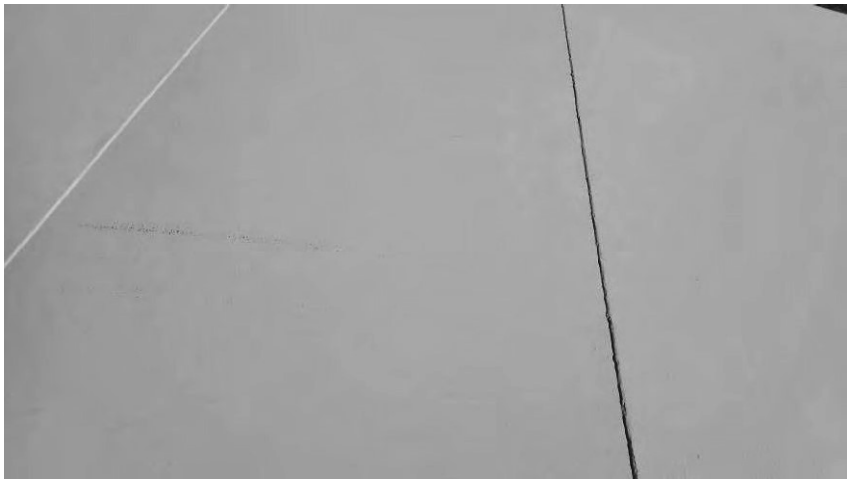
Image #10

Roof 9:00

Condition:
Rust Grade¹ 9.

Description:
Roof appeared to be in good condition with a minor amount of corrosion.

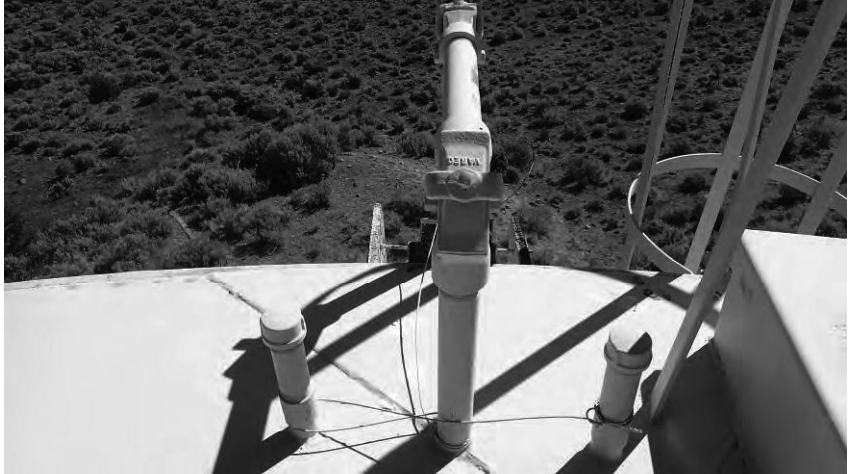
Image #11

Condition:
Rust Grade 3.

Description:
1 1/2" Liquid Level Indicator Penetration appeared to be in good condition with a minor amount of corrosion.

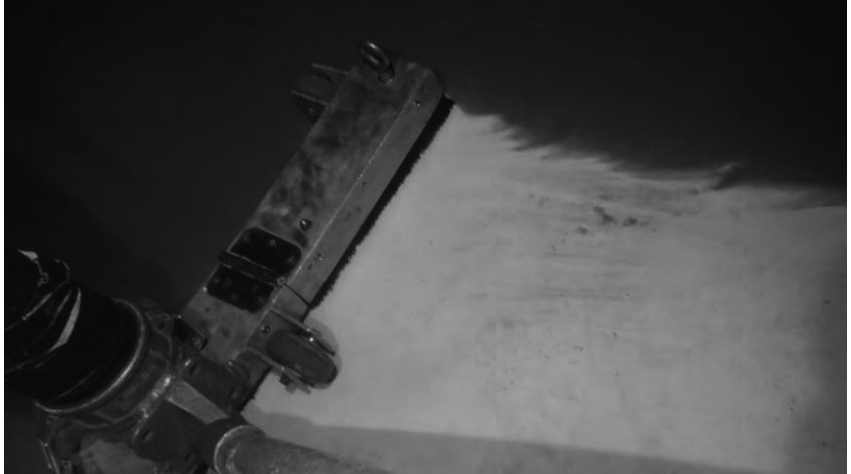
Image #13

Description:

1/16" of sediment was removed from reservoir floor.

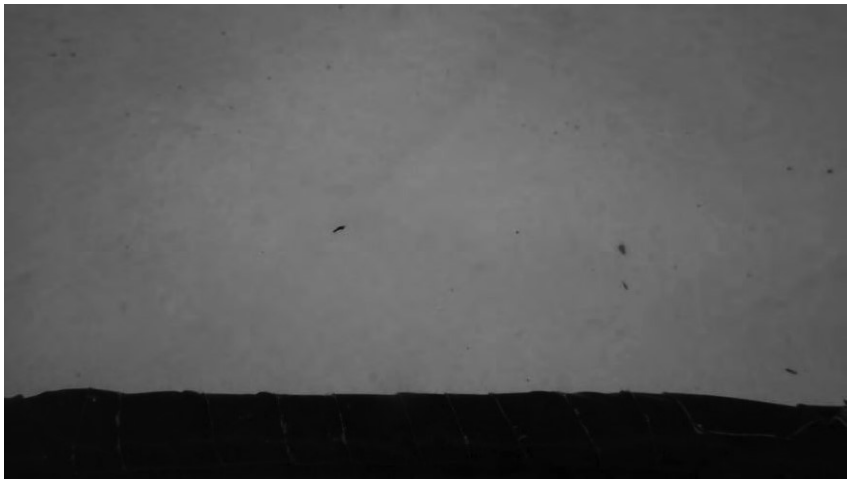
Image #14

Floor 12:00

Condition:
Rust Grade¹ 8.

Description:

Floor appeared to be in good condition with a minor amount of corrosion.

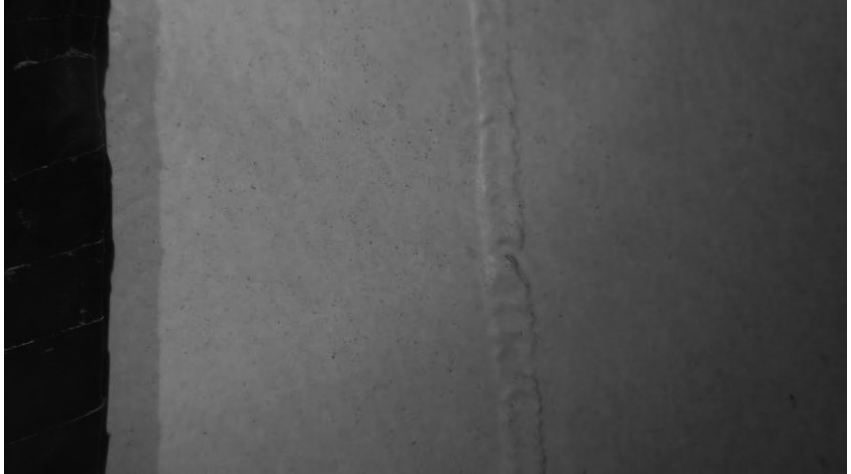
Image #15

Condition:
Rust Grade¹ 3.

Description:
Wall appeared to be in good condition with a minor amount of corrosion.

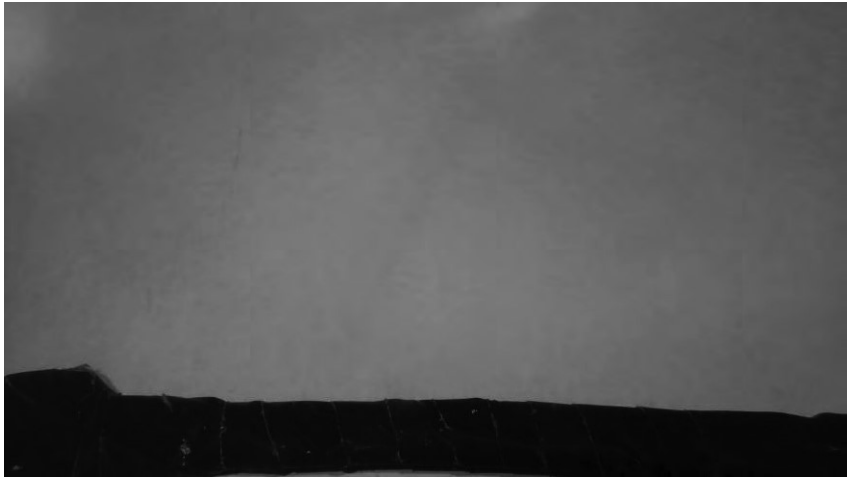
Image #16

Floor 3:00

Condition:
Rust Grade¹ 3.

Description:
Floor appeared to be in good condition with a minor amount of corrosion.

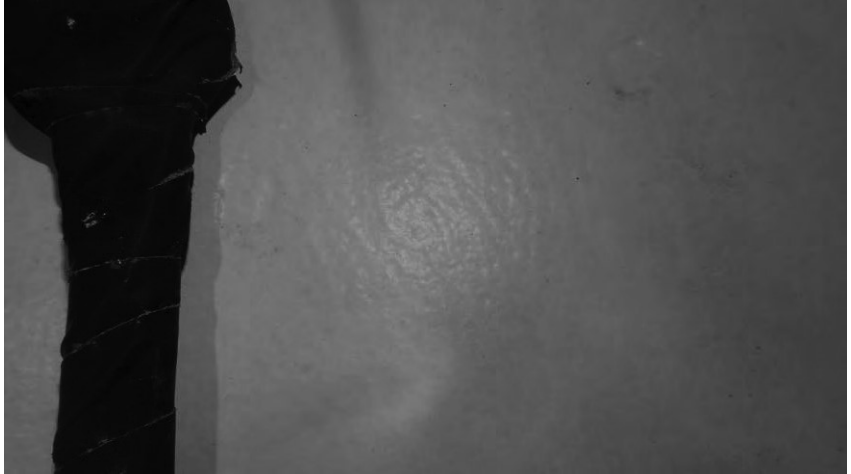
Image #17

Condition:
Rust Grade¹ 3.

Description:
Wall appeared to be in good condition with a minor amount of corrosion.

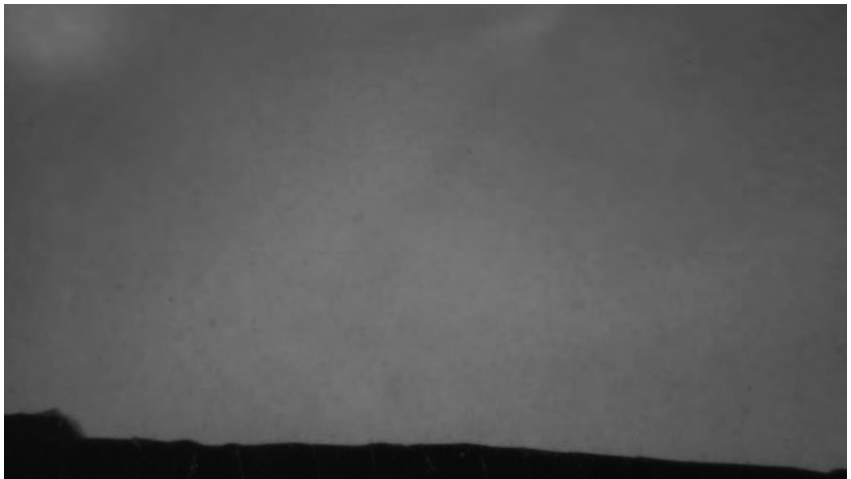
Image #18

Floor 6:00

Condition:
Rust Grade¹ 3.

Description:
Floor appeared to be in good condition with a minor amount of corrosion.

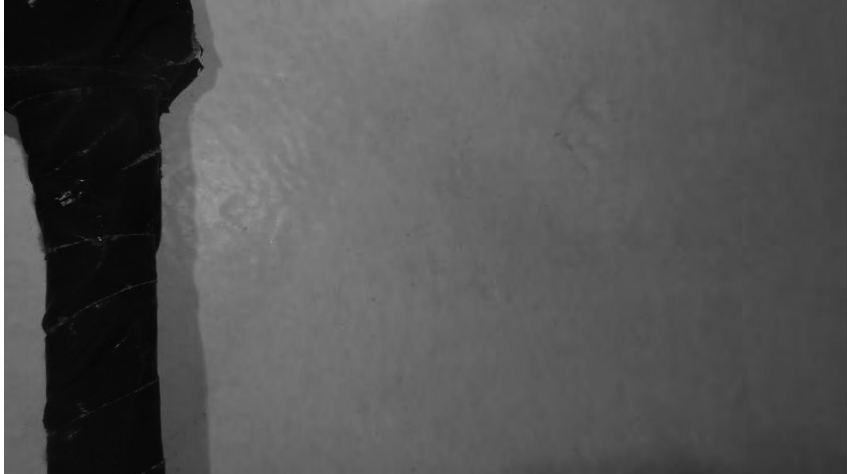
Image #19

Condition:
Rust Grade¹ 8.

Description:
Wall appeared to be in good condition with a minor amount of corrosion.

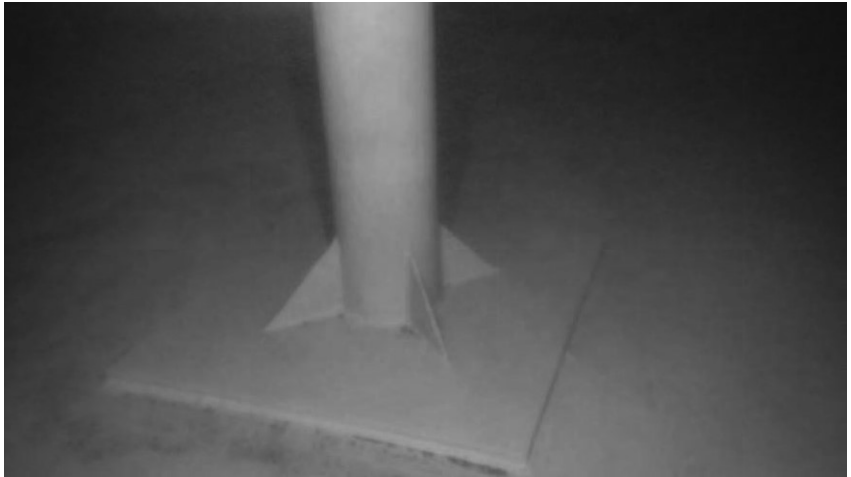
Image #20

Column Base Center

Condition:
Rust Grade¹ 8.

Description:
24" X 24" Column Base appeared to be in good condition with a minor amount of corrosion.

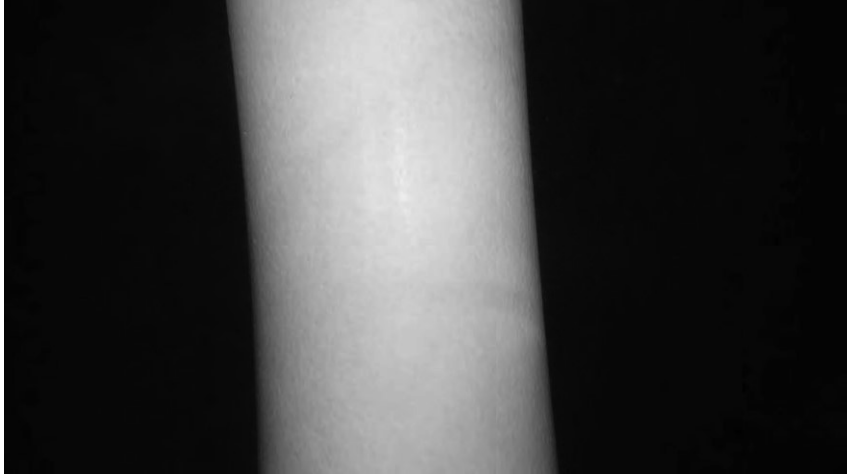
Image #21

Condition:
Rust Grade¹ 3.

Description:
12" Column appeared to be in good condition with a minor amount of corrosion.

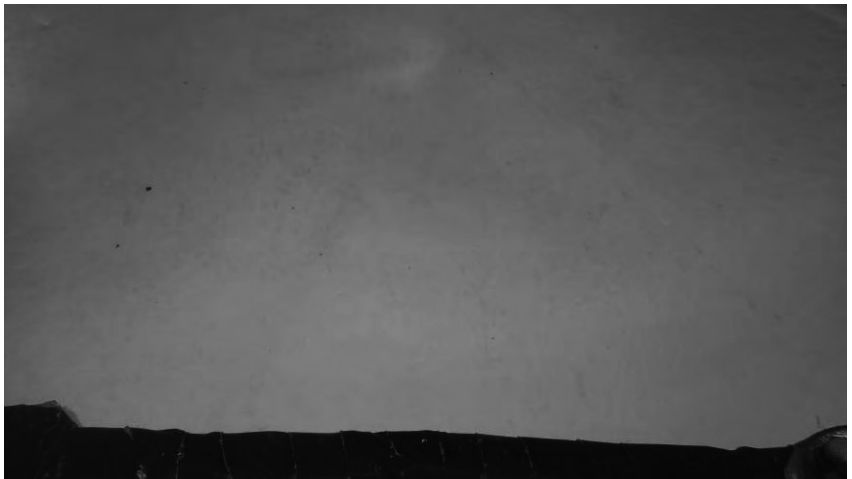
Image #22

Floor 9:00

Condition:
Rust Grade¹ 3.

Description:
Floor appeared to be in good condition with a minor amount of corrosion.

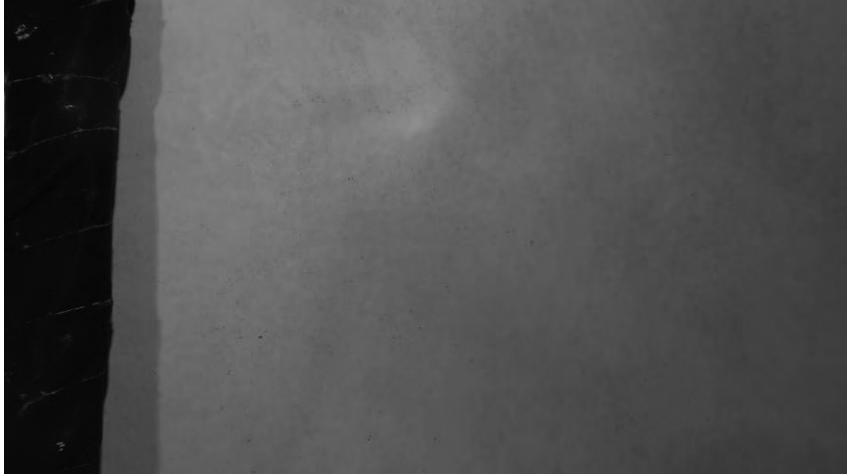
Image #23

Condition:
Rust Grade¹ 3.

Description:
Wall appeared to be in good condition with a minor amount of corrosion.

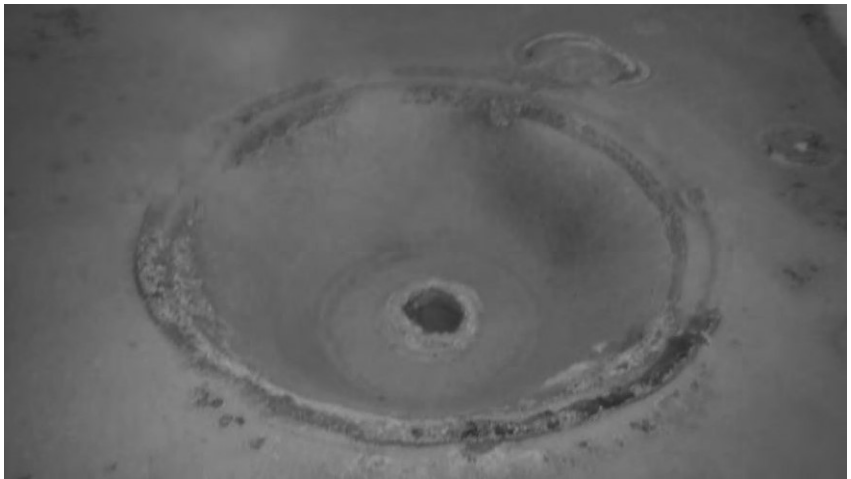
Image #24

Drain 9:15

Condition:
Rust Grade¹ 5.

Description:
12" to 3" Drain appeared to be in fair condition with a moderate amount of corrosion.

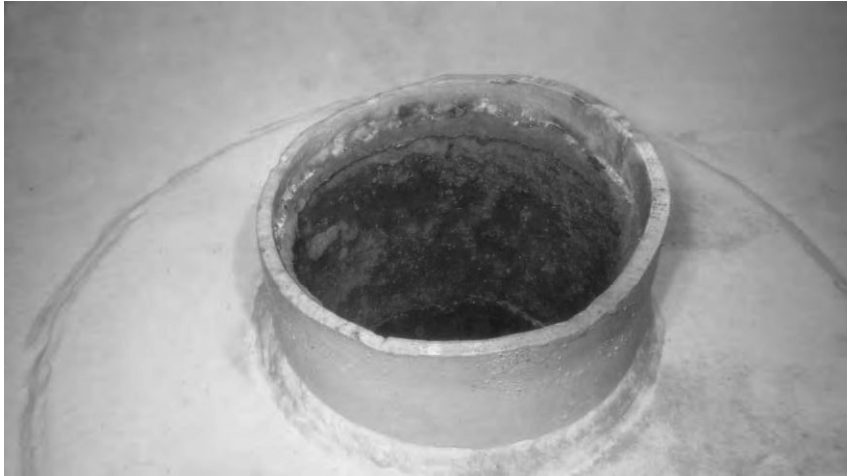
Image #25

Condition:
Rust Grade¹ 6.

Description:
10" Inlet / Outlet appeared to be in fair condition with a moderate amount of corrosion.

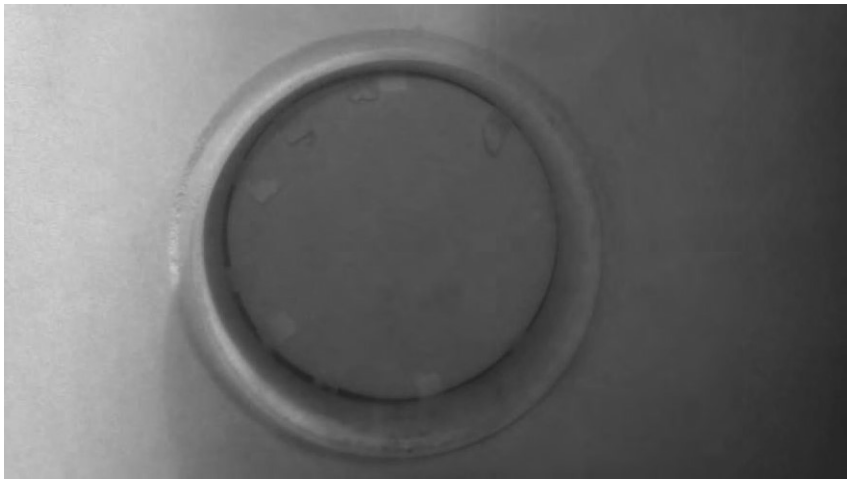
Image #26

Man Way 11:30

Condition:
Rust Grade¹ 8.

Description:
24" Man Way appeared to be in good condition with a minor amount of corrosion.

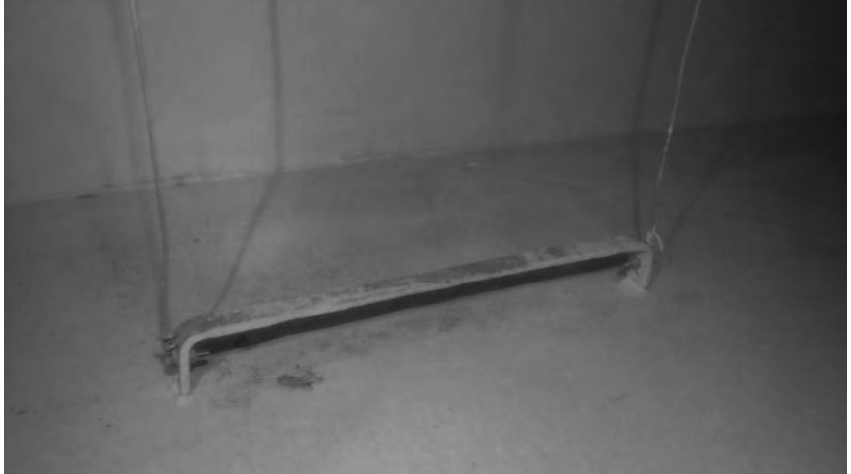
Image #27

Condition:
Rust Grade¹ 3.

Description:
Liquid Level Indicator Base appeared to be in good condition with a minor amount of corrosion.

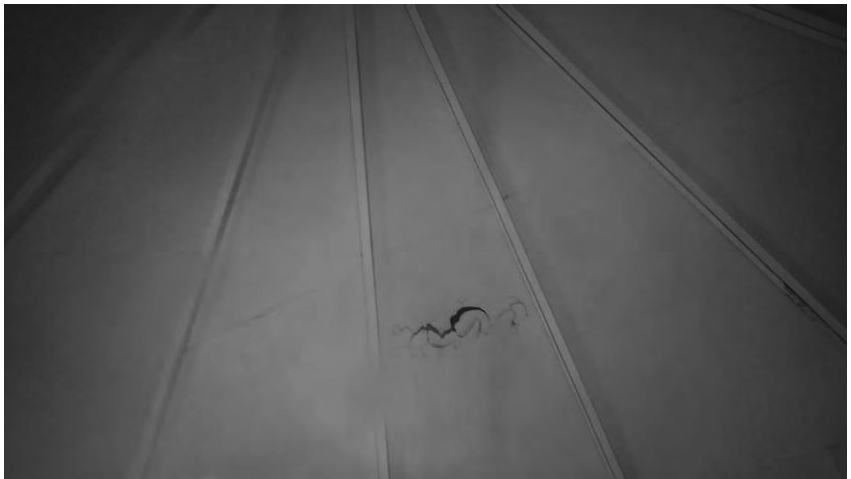
Image #28

Ceiling 12:00

Condition:
Rust Grade¹ 7.

Description:
Ceiling appeared to be in fair condition with a minor amount of corrosion. Coating failure.

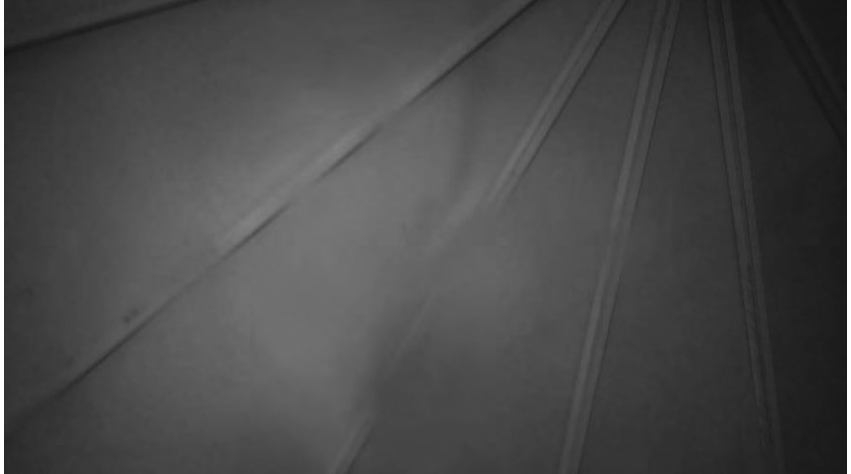
Image #29

Condition:
Rust Grade¹ 8.

Description:
Ceiling appeared to be in good condition with a minor amount of corrosion.

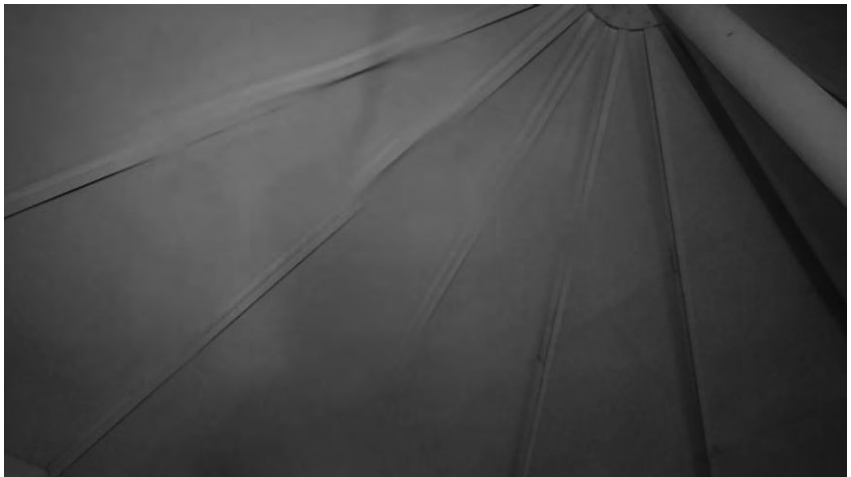
Image #30

Ceiling 6:00

Condition:
Rust Grade¹ 8.

Description:
Ceiling appeared to be in good condition with a minor amount of corrosion.

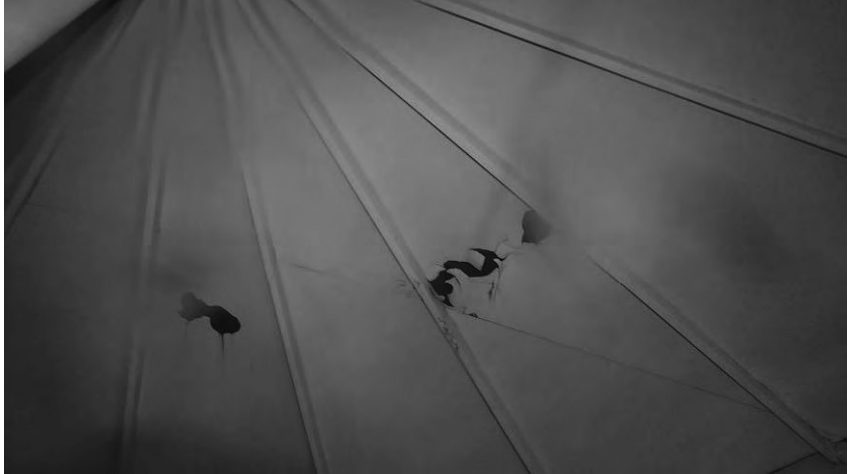
Image #31

Condition:
Rust Grade¹ 7.

Description:
Ceiling appeared to be in fair condition with a minor amount of corrosion. Coating failure.

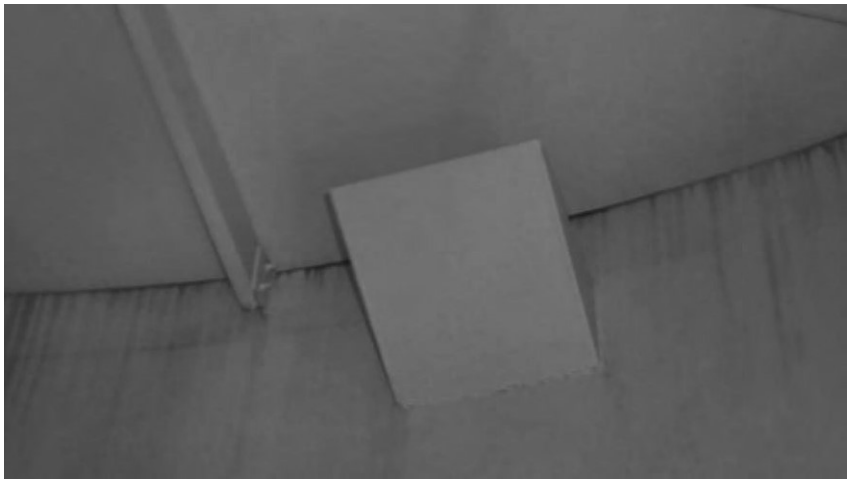
Image #32

Overflow 9:00

Condition:
Rust Grade¹ 8.

Description:
12" X 6" Overflow appeared to be in good condition with a minor amount of corrosion.

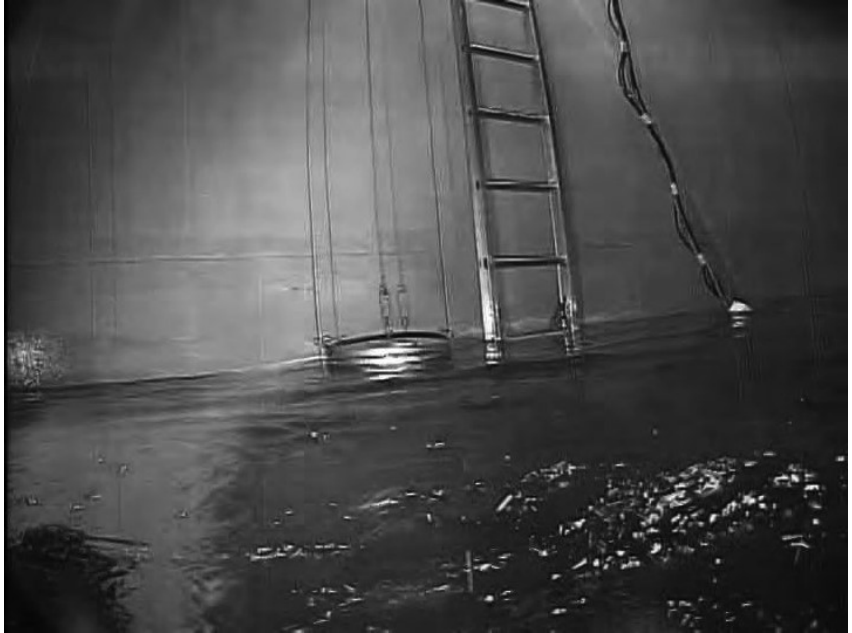
Image #33

Condition:
Rust Grade¹ 7.

Description:
Liquid Level Indicator Float
appeared to be in fair condition
with a minor amount of
corrosion.
